Debris/Ice/TPS Assessment And Photographic Analysis For Shuttle Mission STS-28R

September 1989

DEBRIS/ICE/TPS ASSESSMENT
AND
PHOTOGRAPHIC ANALYSIS
OF
SHUTTLE MISSION STS-28R

AUGUST 8, 1989

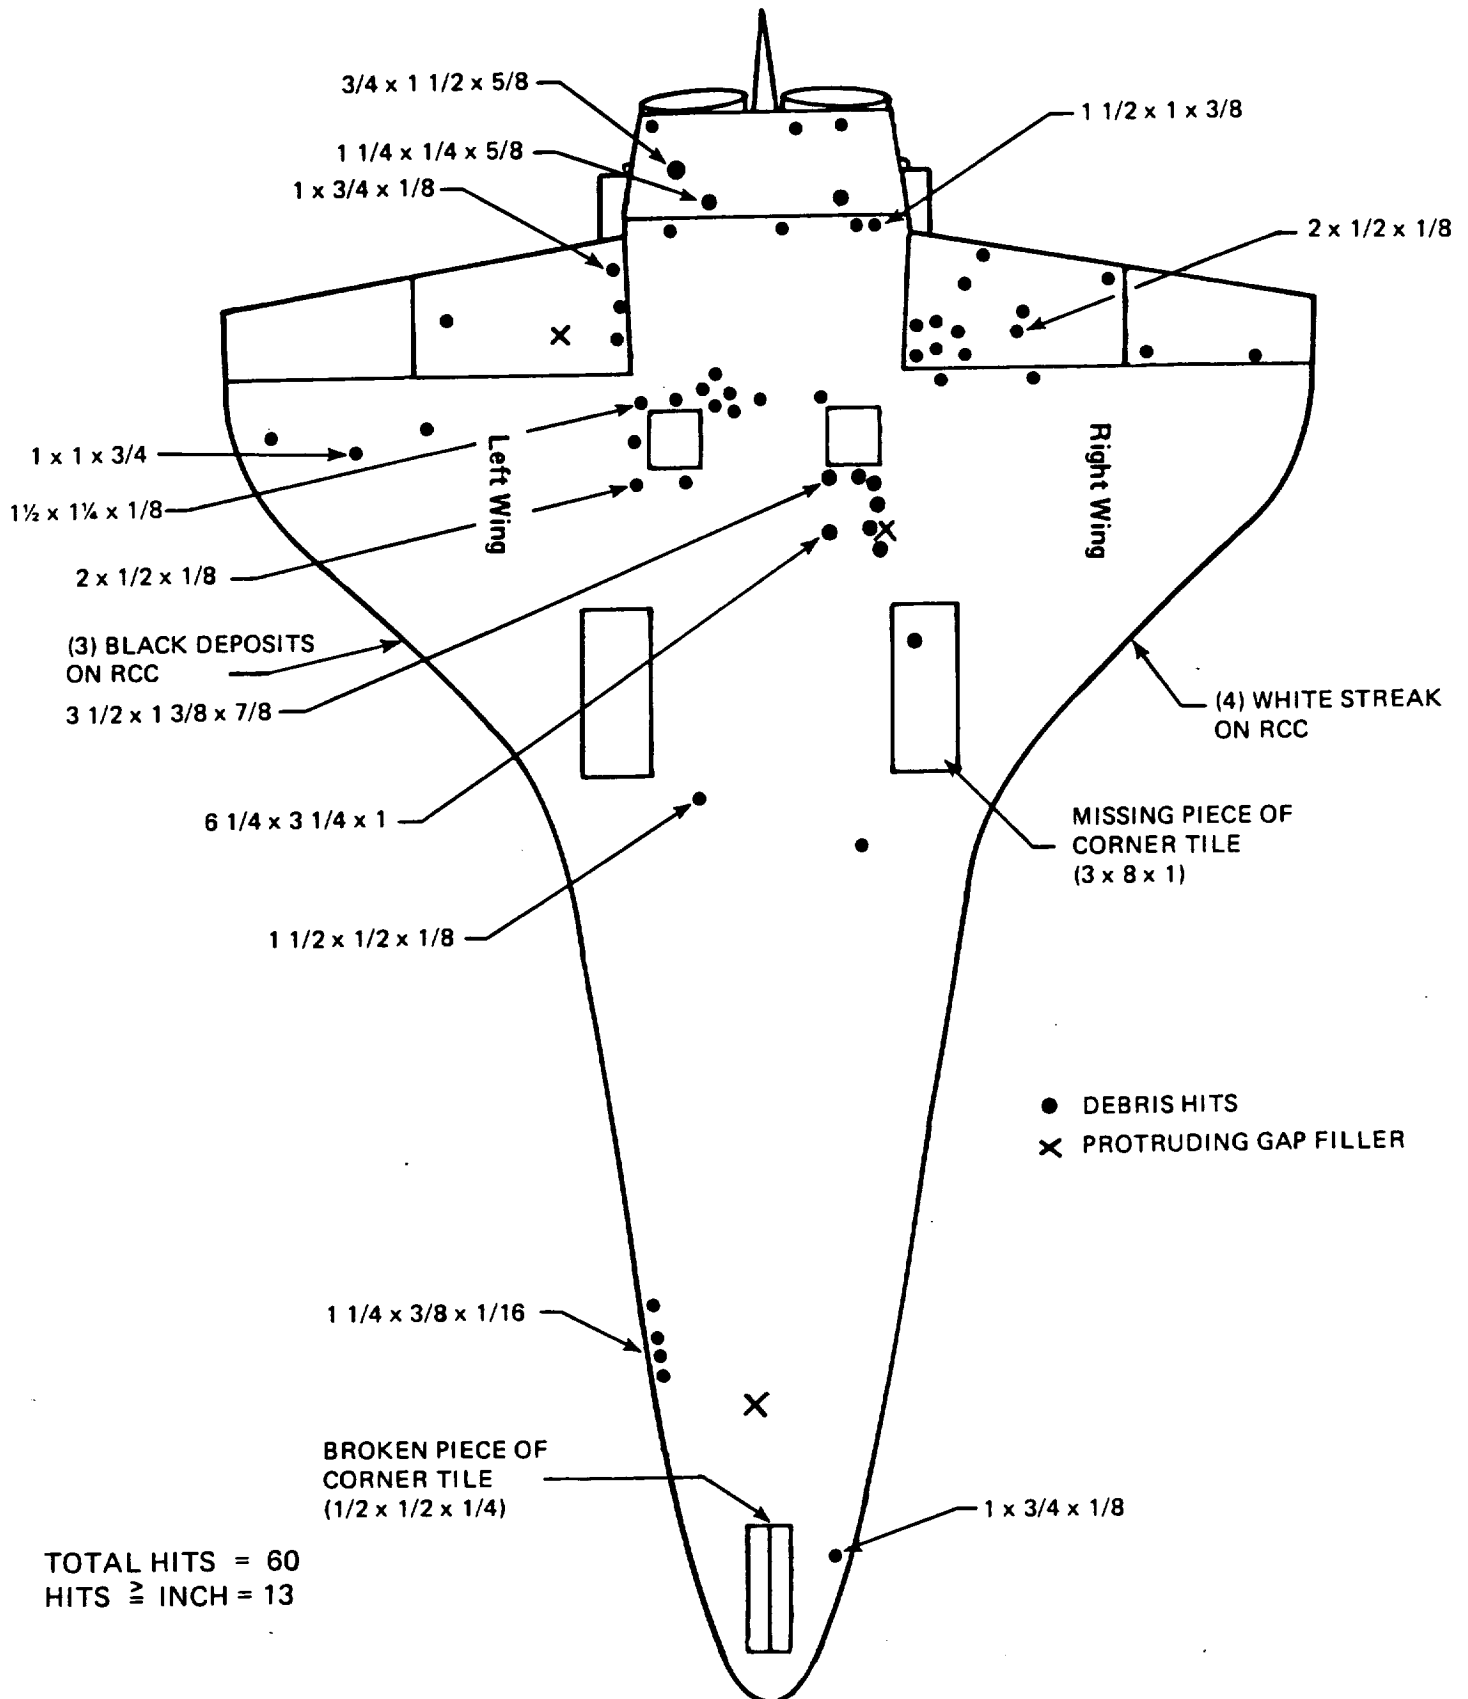
FIGURE 15. DEBRIS DAMAGE LOCATIONS

The majority of the lower surface damage was concentrated aft of the main landing gear doors in an amount approximately equal on each side of the centerline. The most significant damage site measured 6-1/4"x3-1/4"x1" and was located forward of the ET/ORB LO2 umbilical. Just aft of this site, a 3-1/2"x1-3/8"x7/8" damage site occurred. Both sites were glazed from reentry heating and were probably caused by the 23x15x1 inch piece of ET intertank SOFI debris. Figures 14-17 illustrate the TPS debris damage assessment for STS-28R. Figures 18 and 19 show detail of the larger damage sites on the lower surface. Samples from selected sites were taken for laboratory analysis in an attempt to identify the sources of TPS damage. Three protruding gap fillers were visible on the lower surface. A piece of gap filler sleeving approximately 6 inches long was loose between the right wing elevons. No detectable damage to adjacent tiles resulted from these gap fillers.

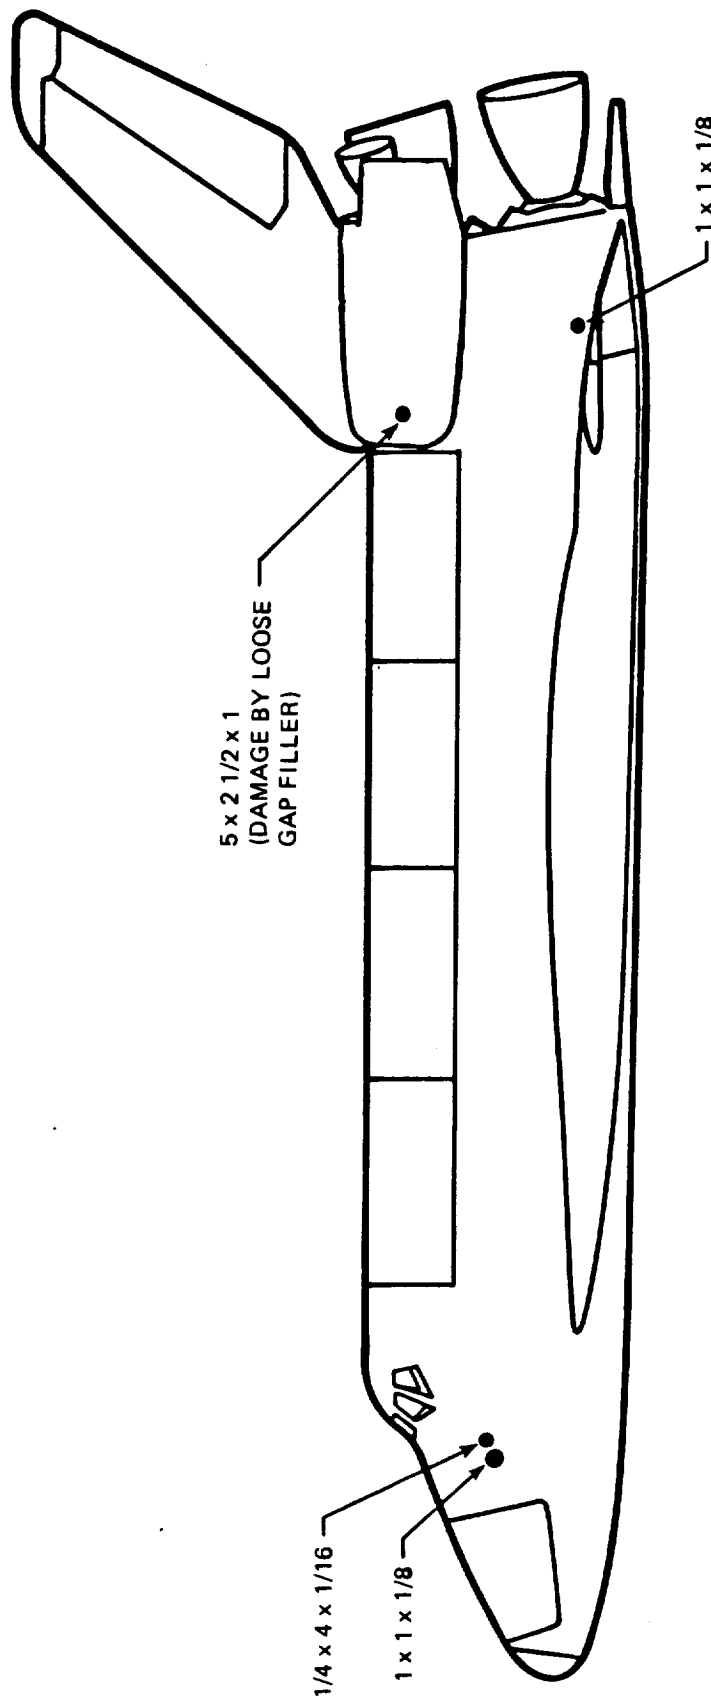
FIGURE 17. DEBRIS DAMAGE LOCATIONS

TOTAL HITS = 4
HITS \geq 1 INCH = 4

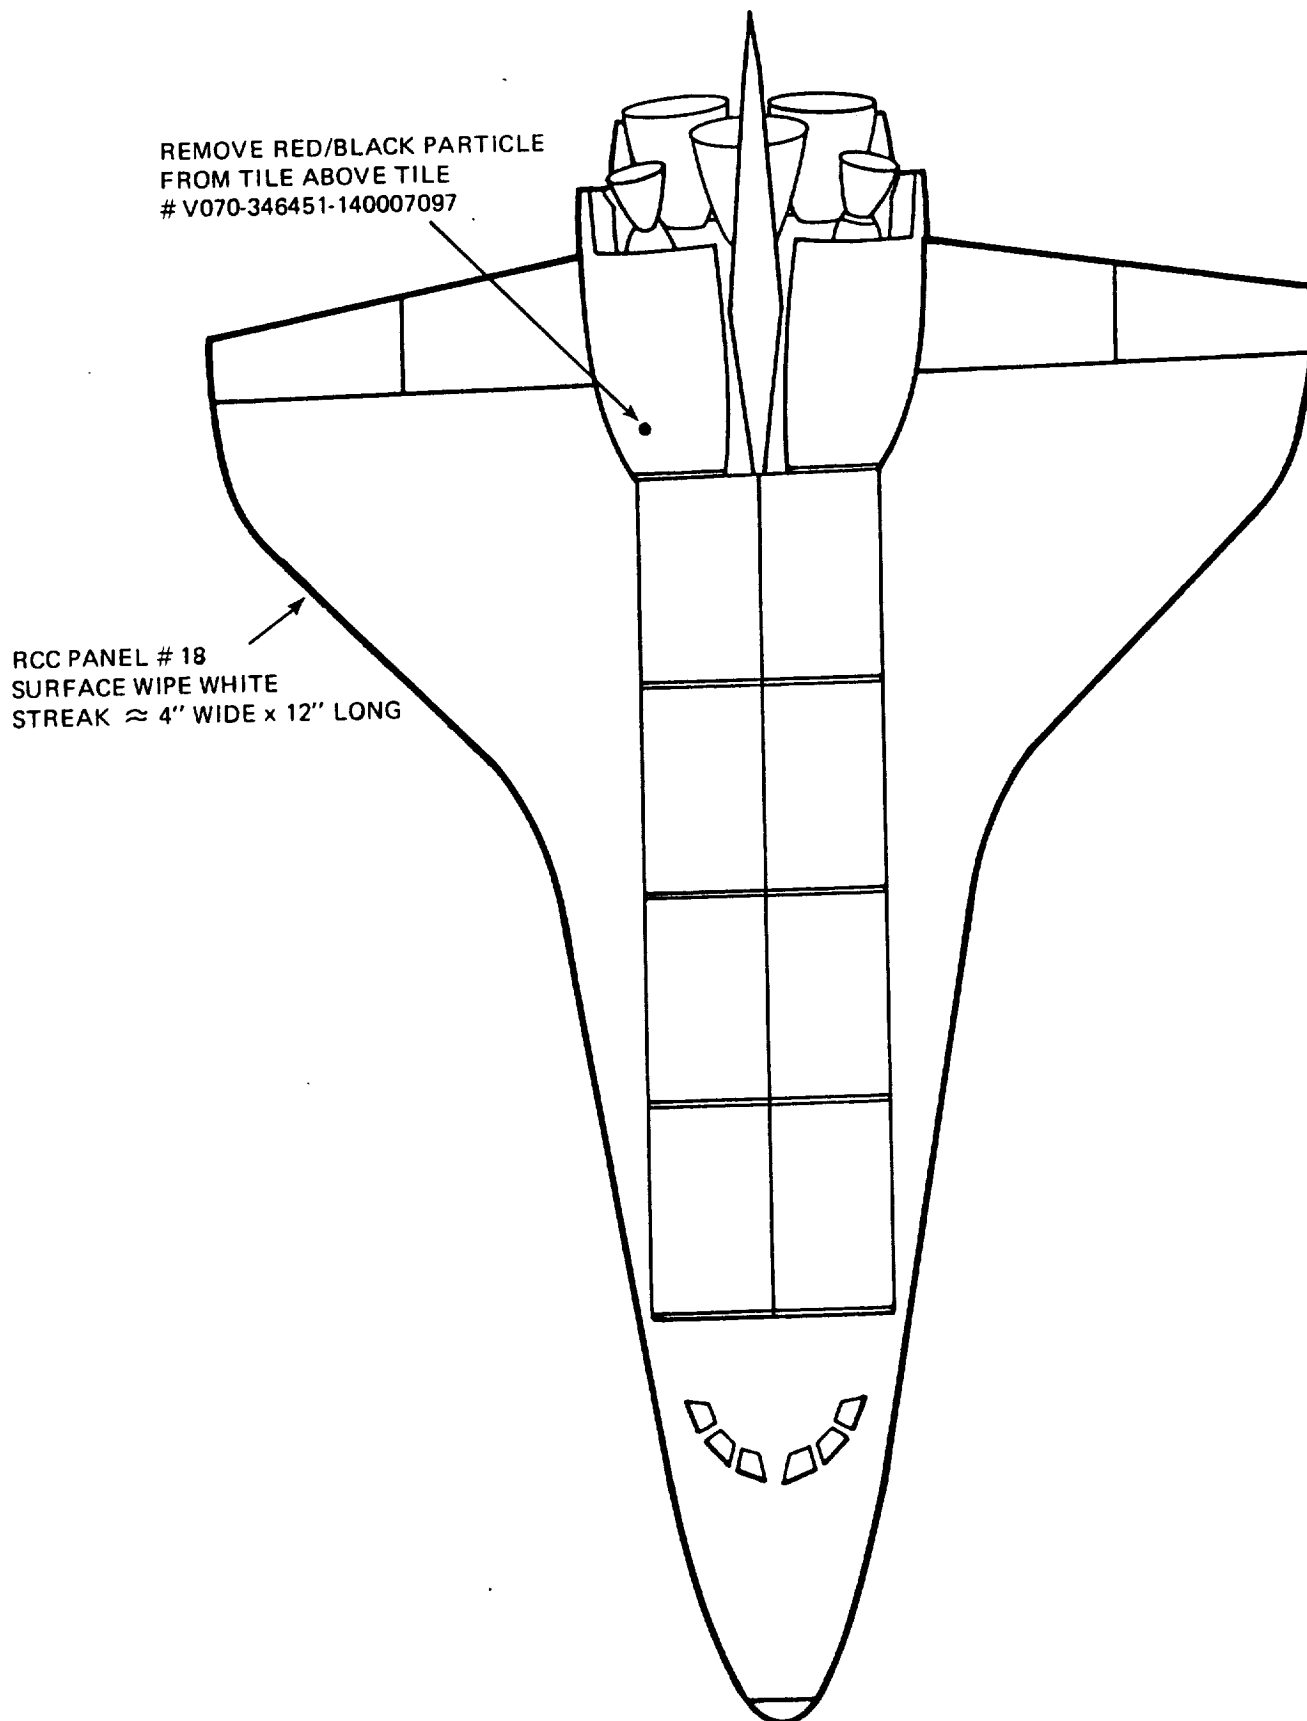
FIGURE 20. DEBRIS SAMPLE LOCATIONS

Orbiter window #3 was heavily hazed; window #4 was less hazed. Window #5 exhibited a 6 inch long by 1 inch wide deposit. Laboratory analysis was performed on samples taken from all windows and was most likely adhesive from the forward RCS paper covers (Report MCB-0774-89, Section 9.0). Figures 20 and 21 show the locations for all samples taken from the Orbiter for analysis.

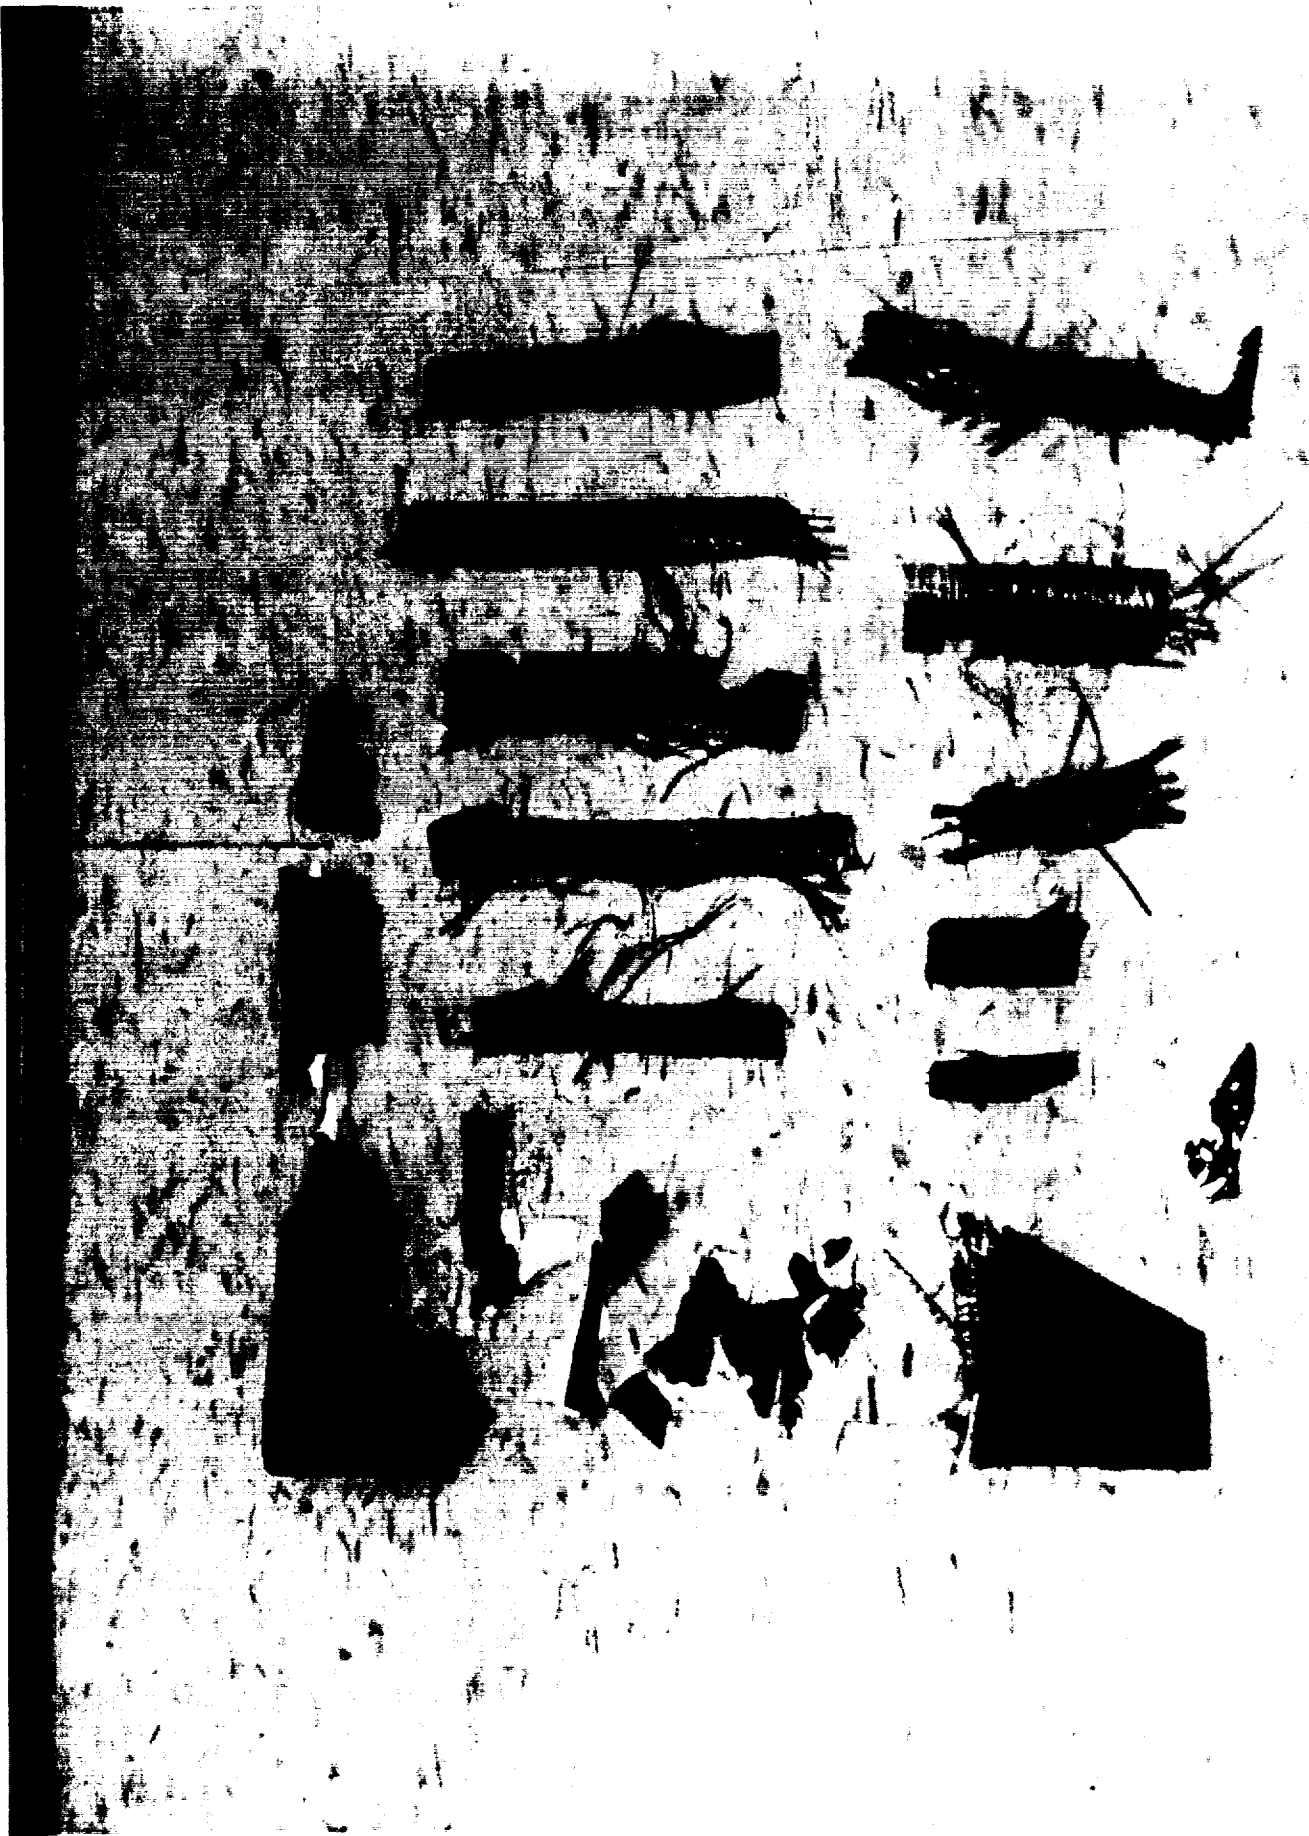
ORBITER TILE PIECES AND AMES GAP FILLERS RECOVERED DURING
POST LANDING RUNWAY INSPECTION

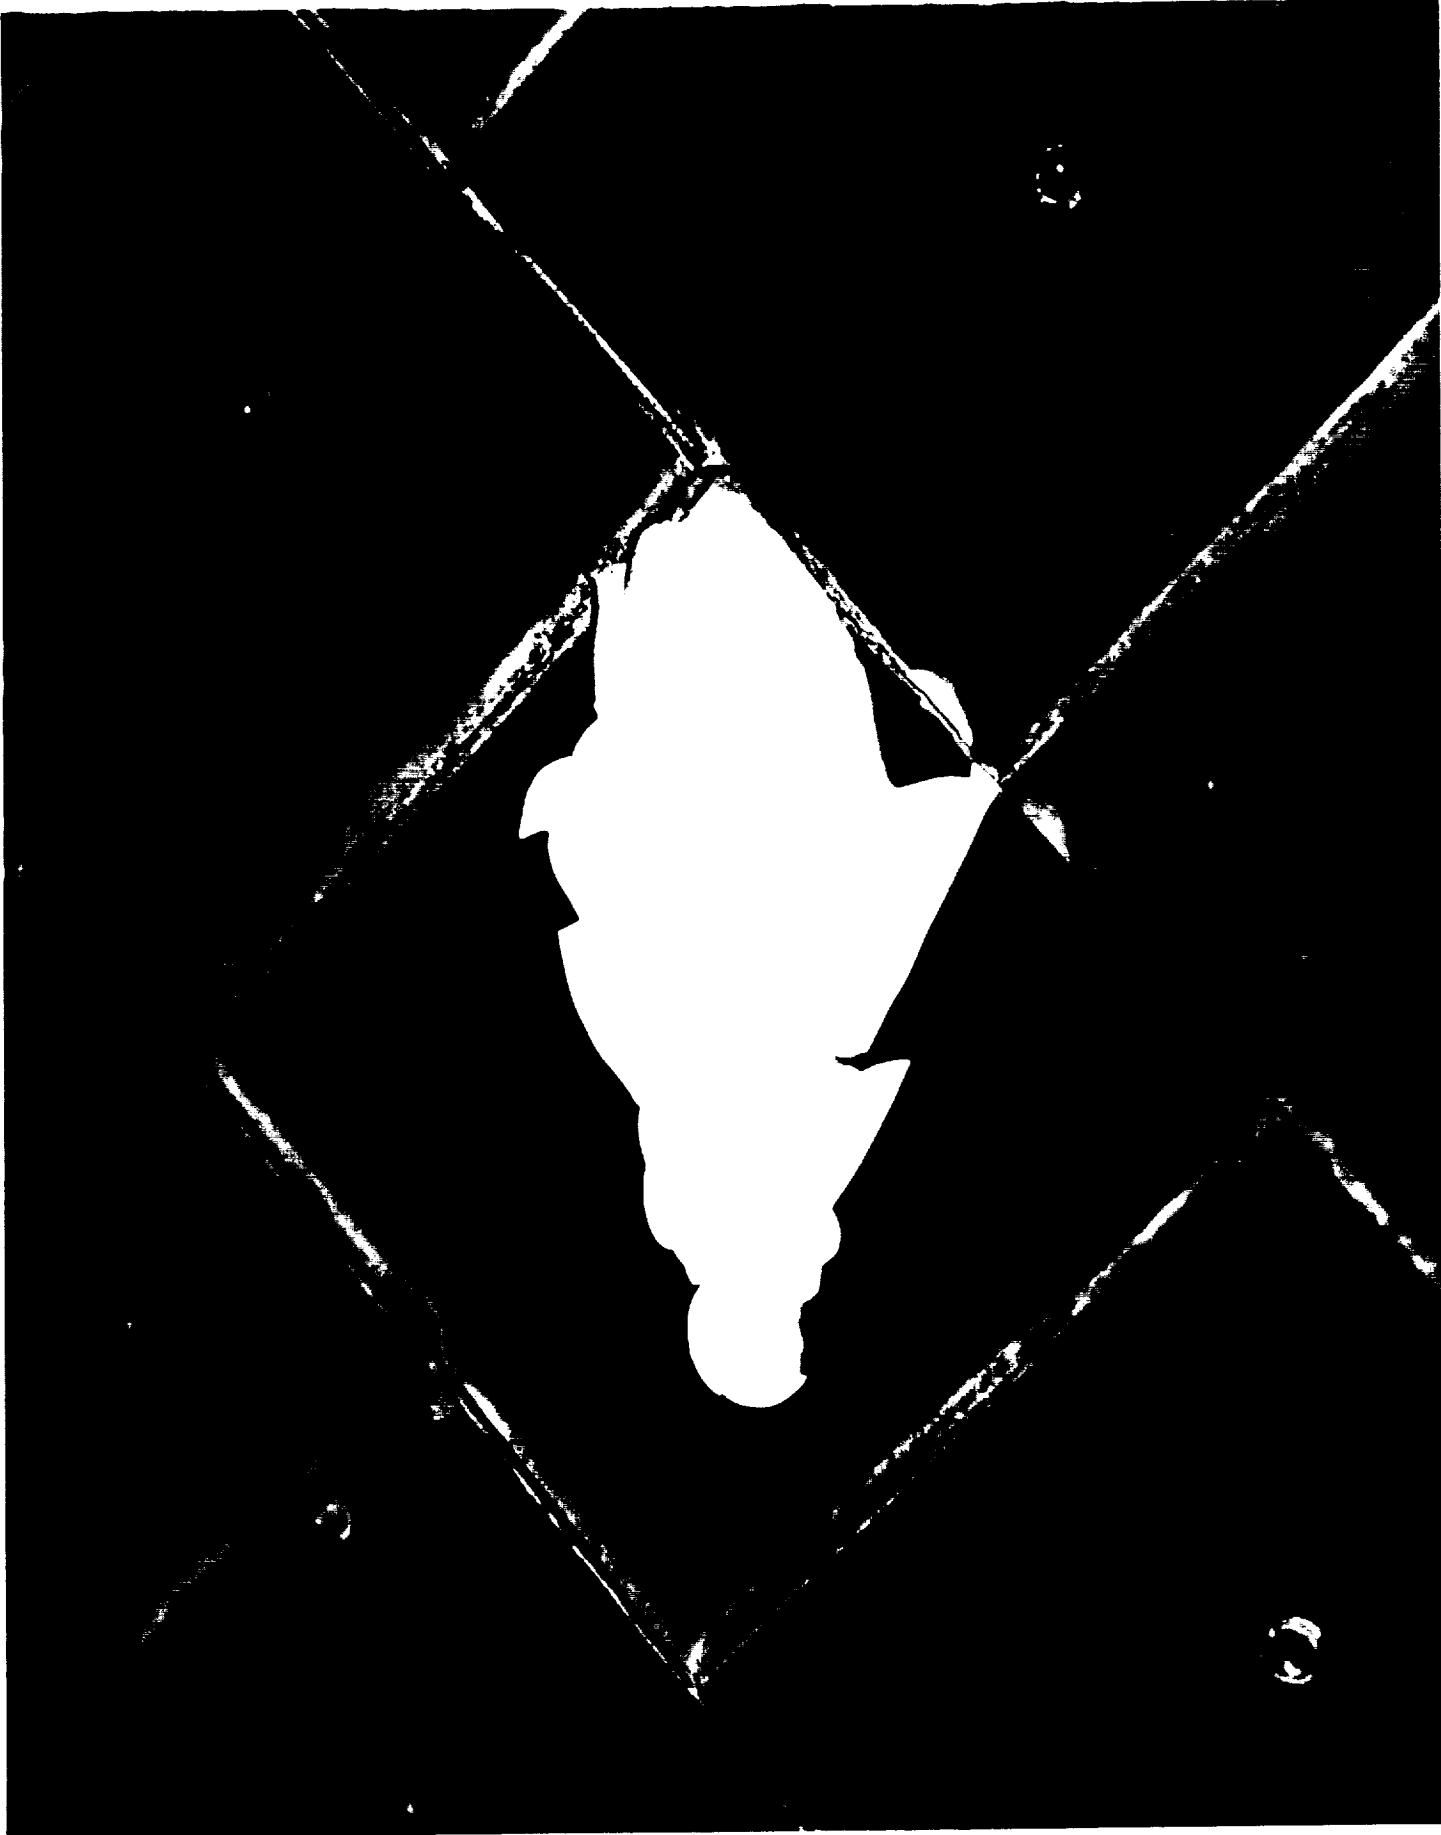
6"x3" DEBRIS IMPACT FORWARD OF LO2 ET/ORB UMBILICAL

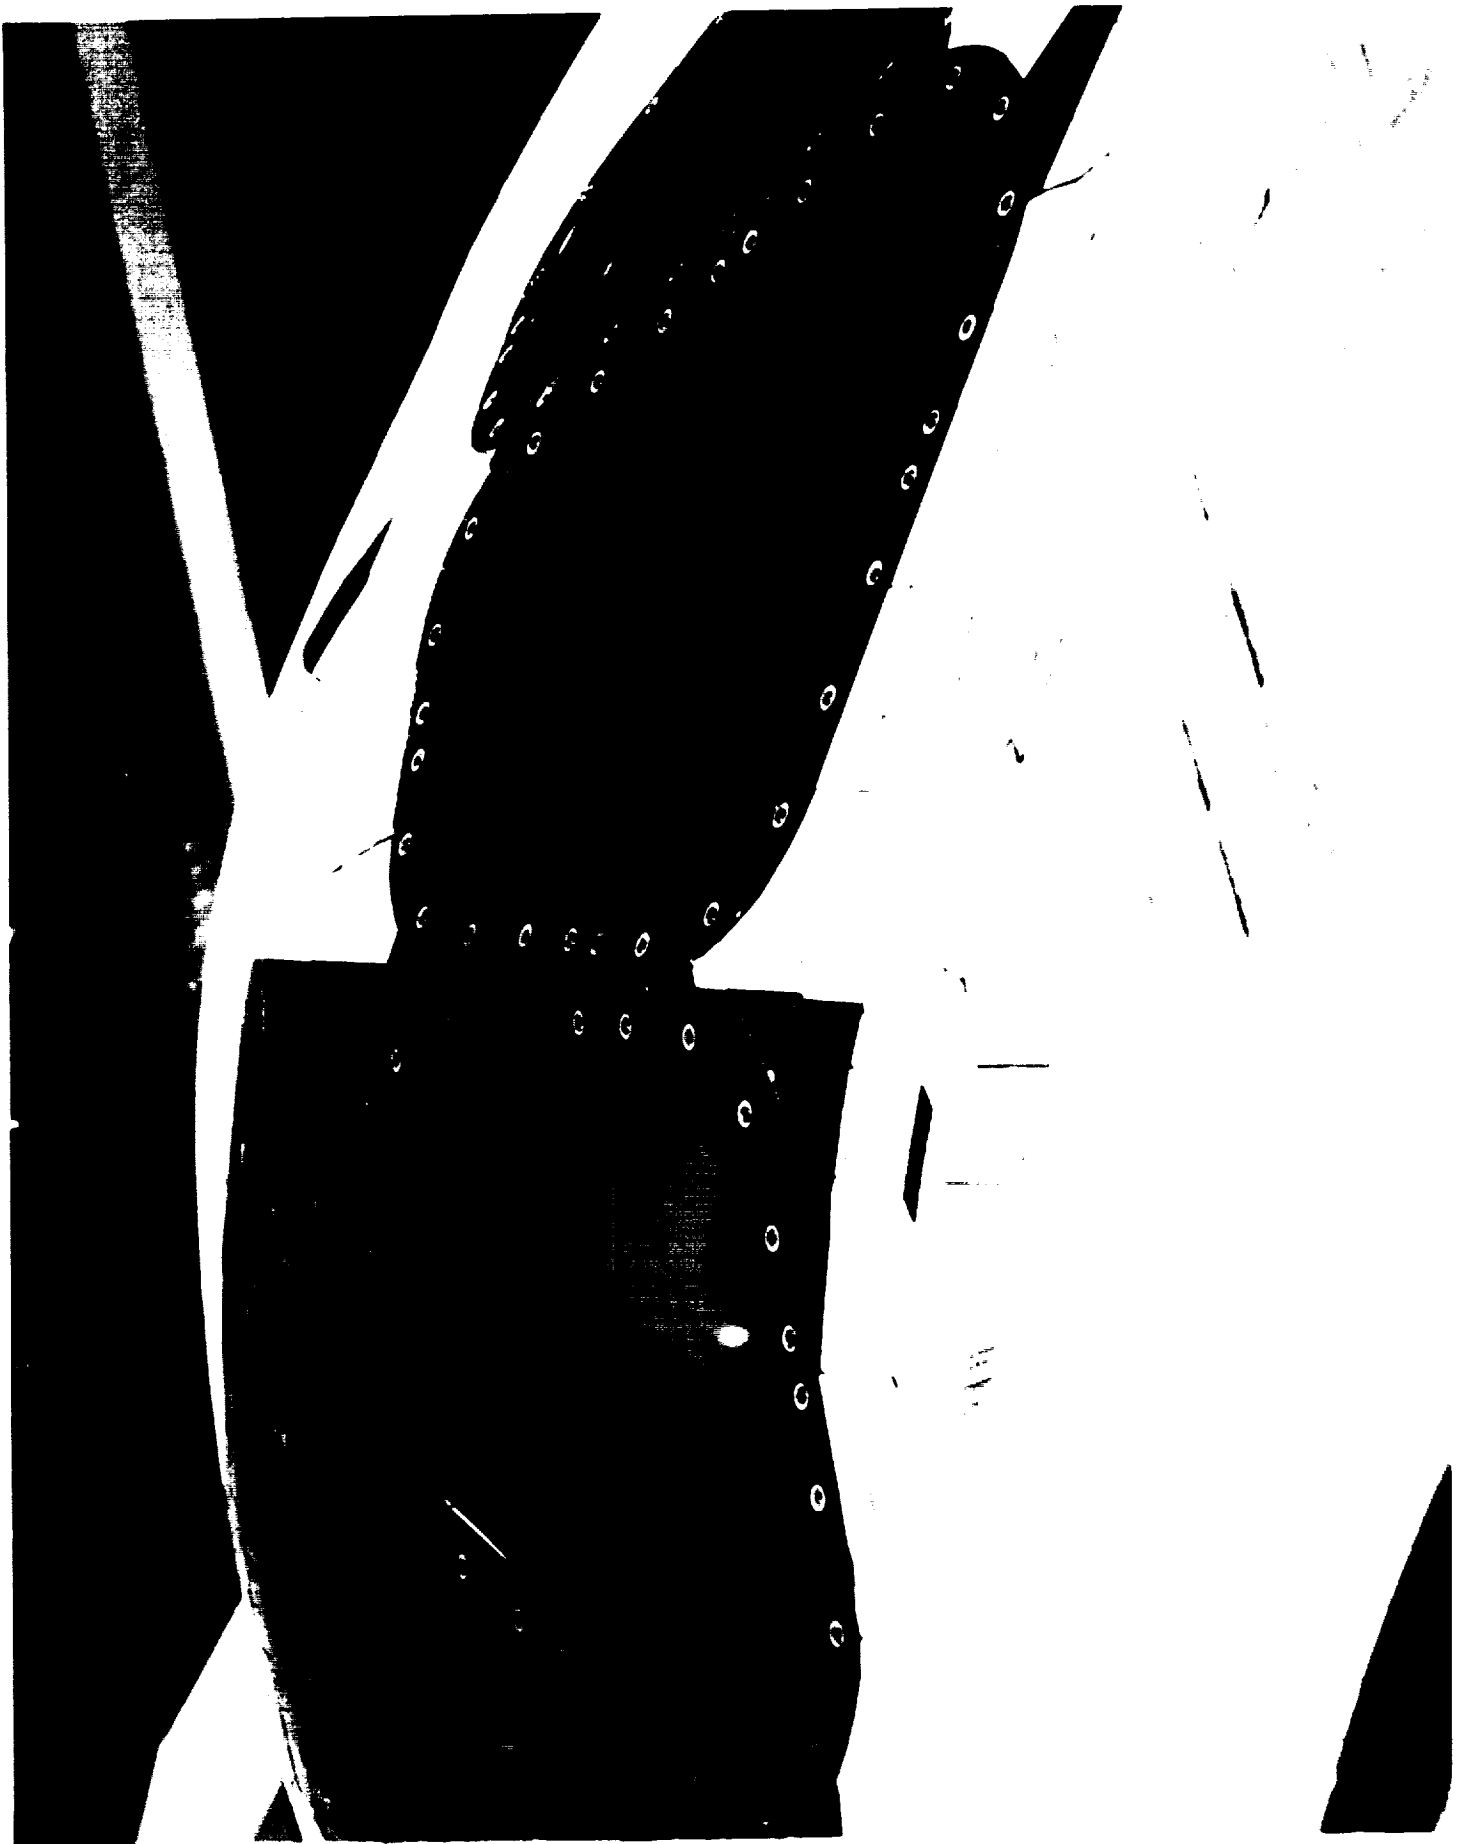
NOTE HAZED WINDOW #3 COMPARED TO CLEAR WINDOW #2

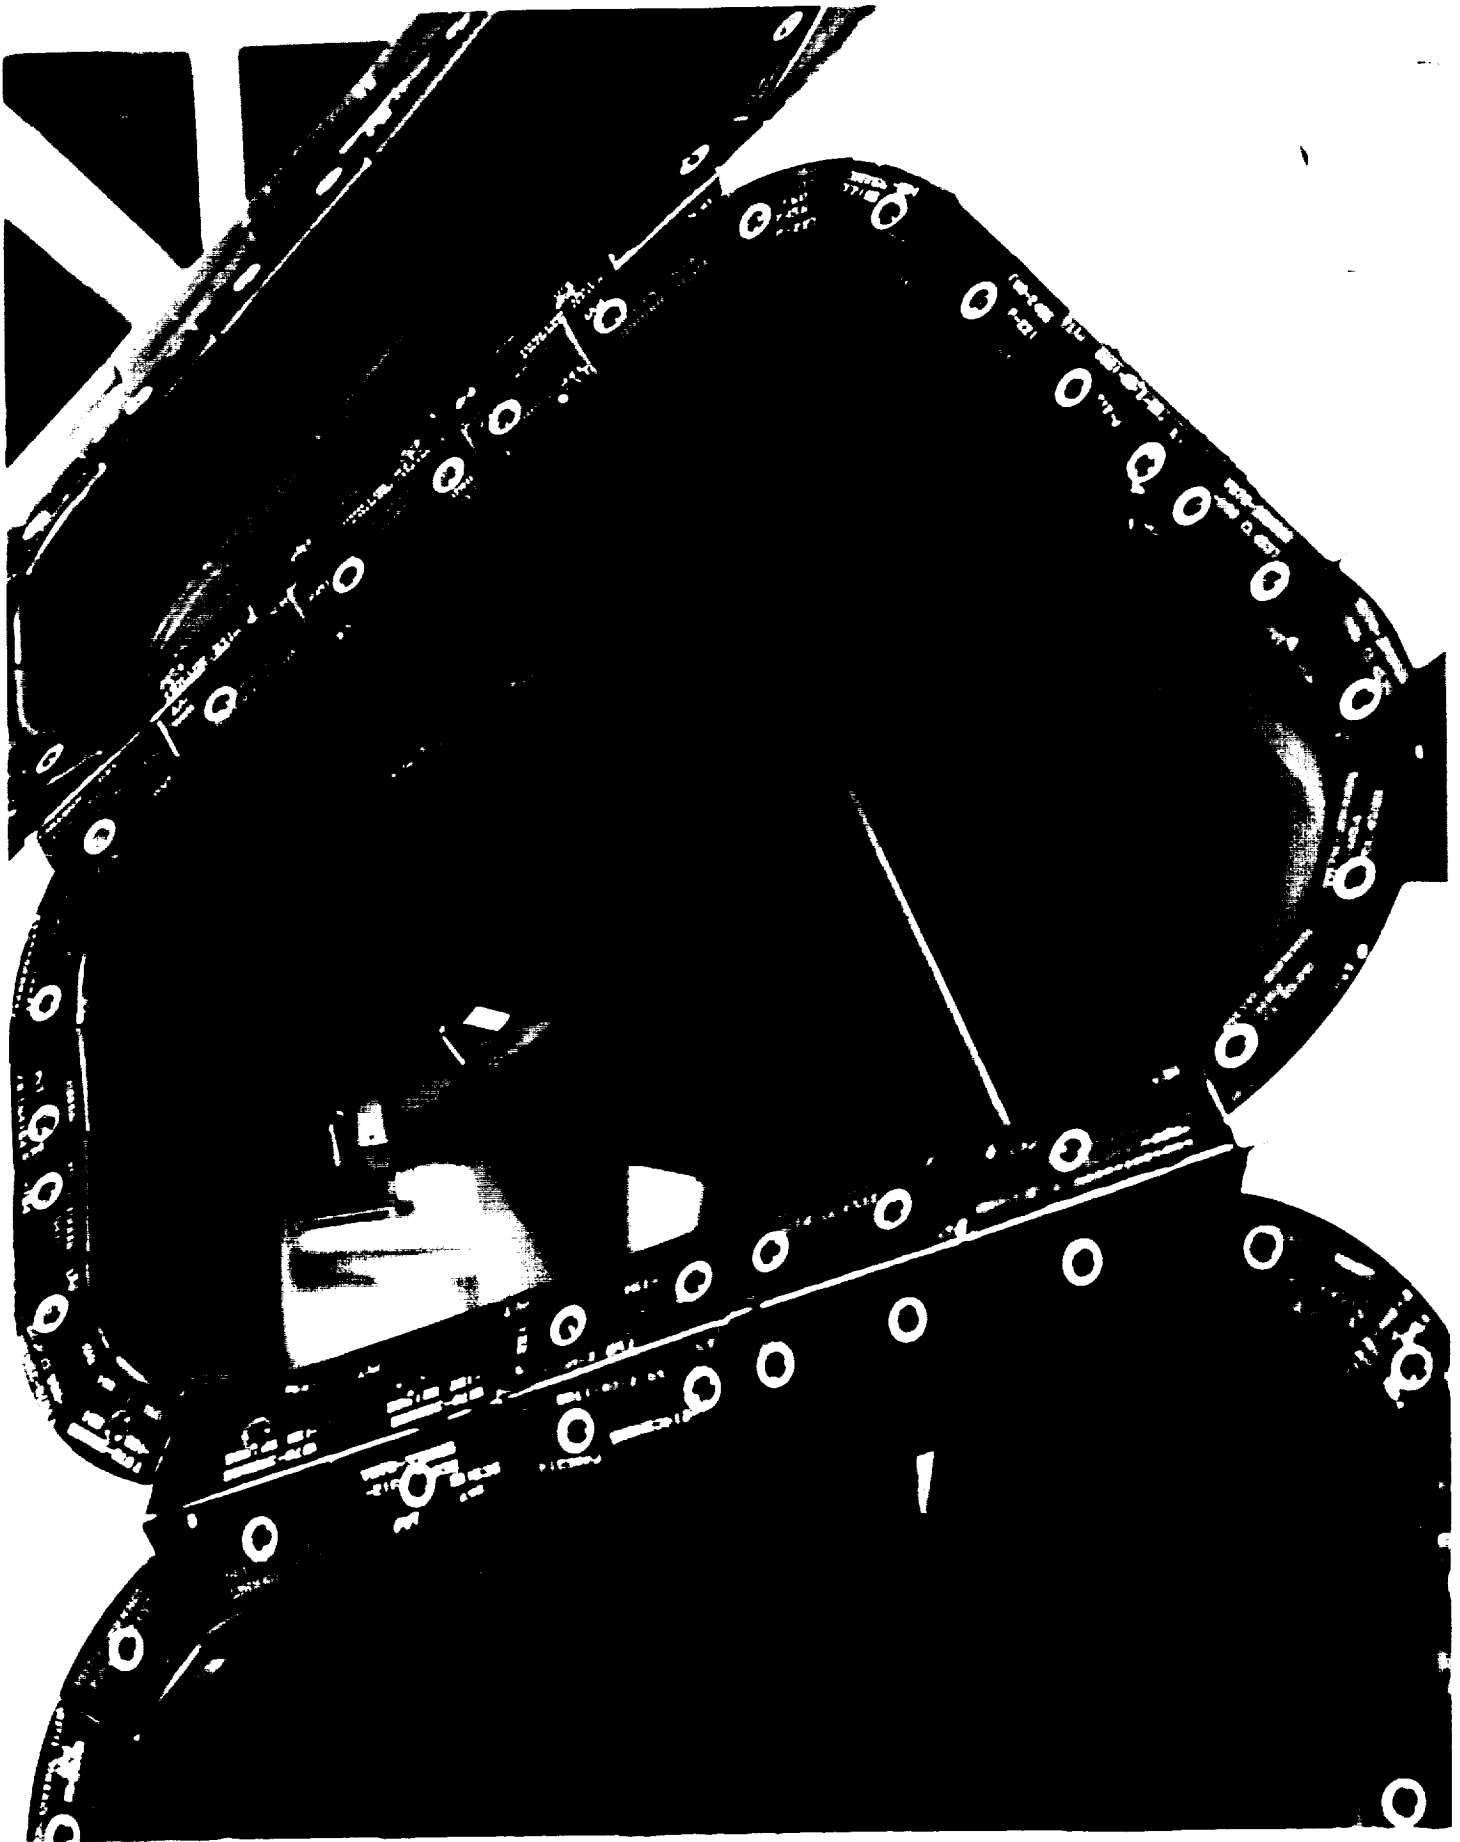
WHITE STREAK ON WINDOW #5

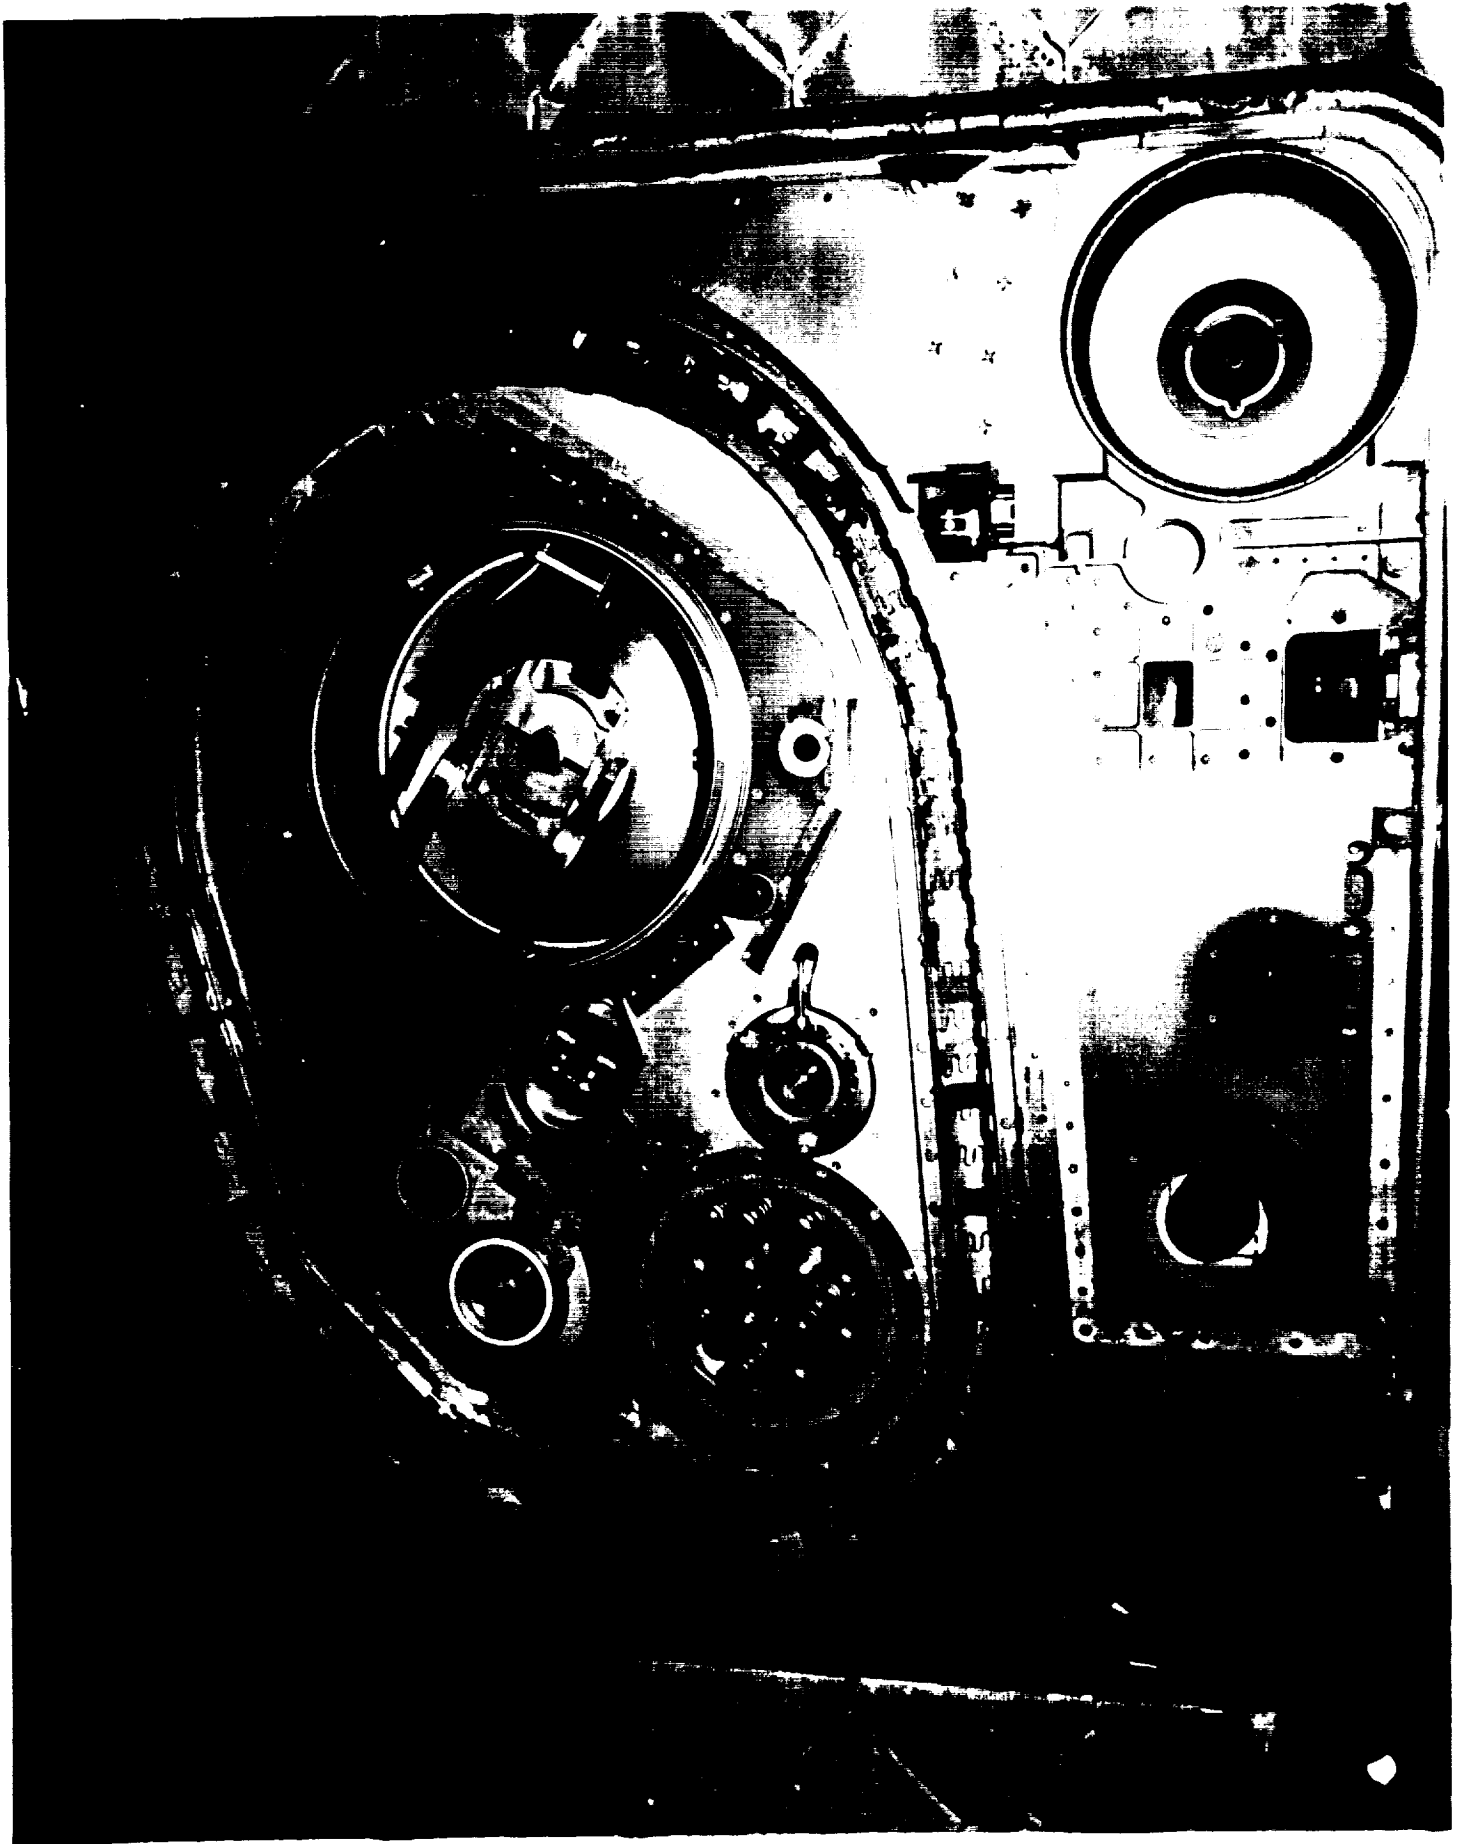
ET/ORB LH2 UMBILICAL. NOTE PIECES OF FOAM ADHERING TO THE
CARRIER PLATE NEAR THE RECIRCULATION LINE VALVE

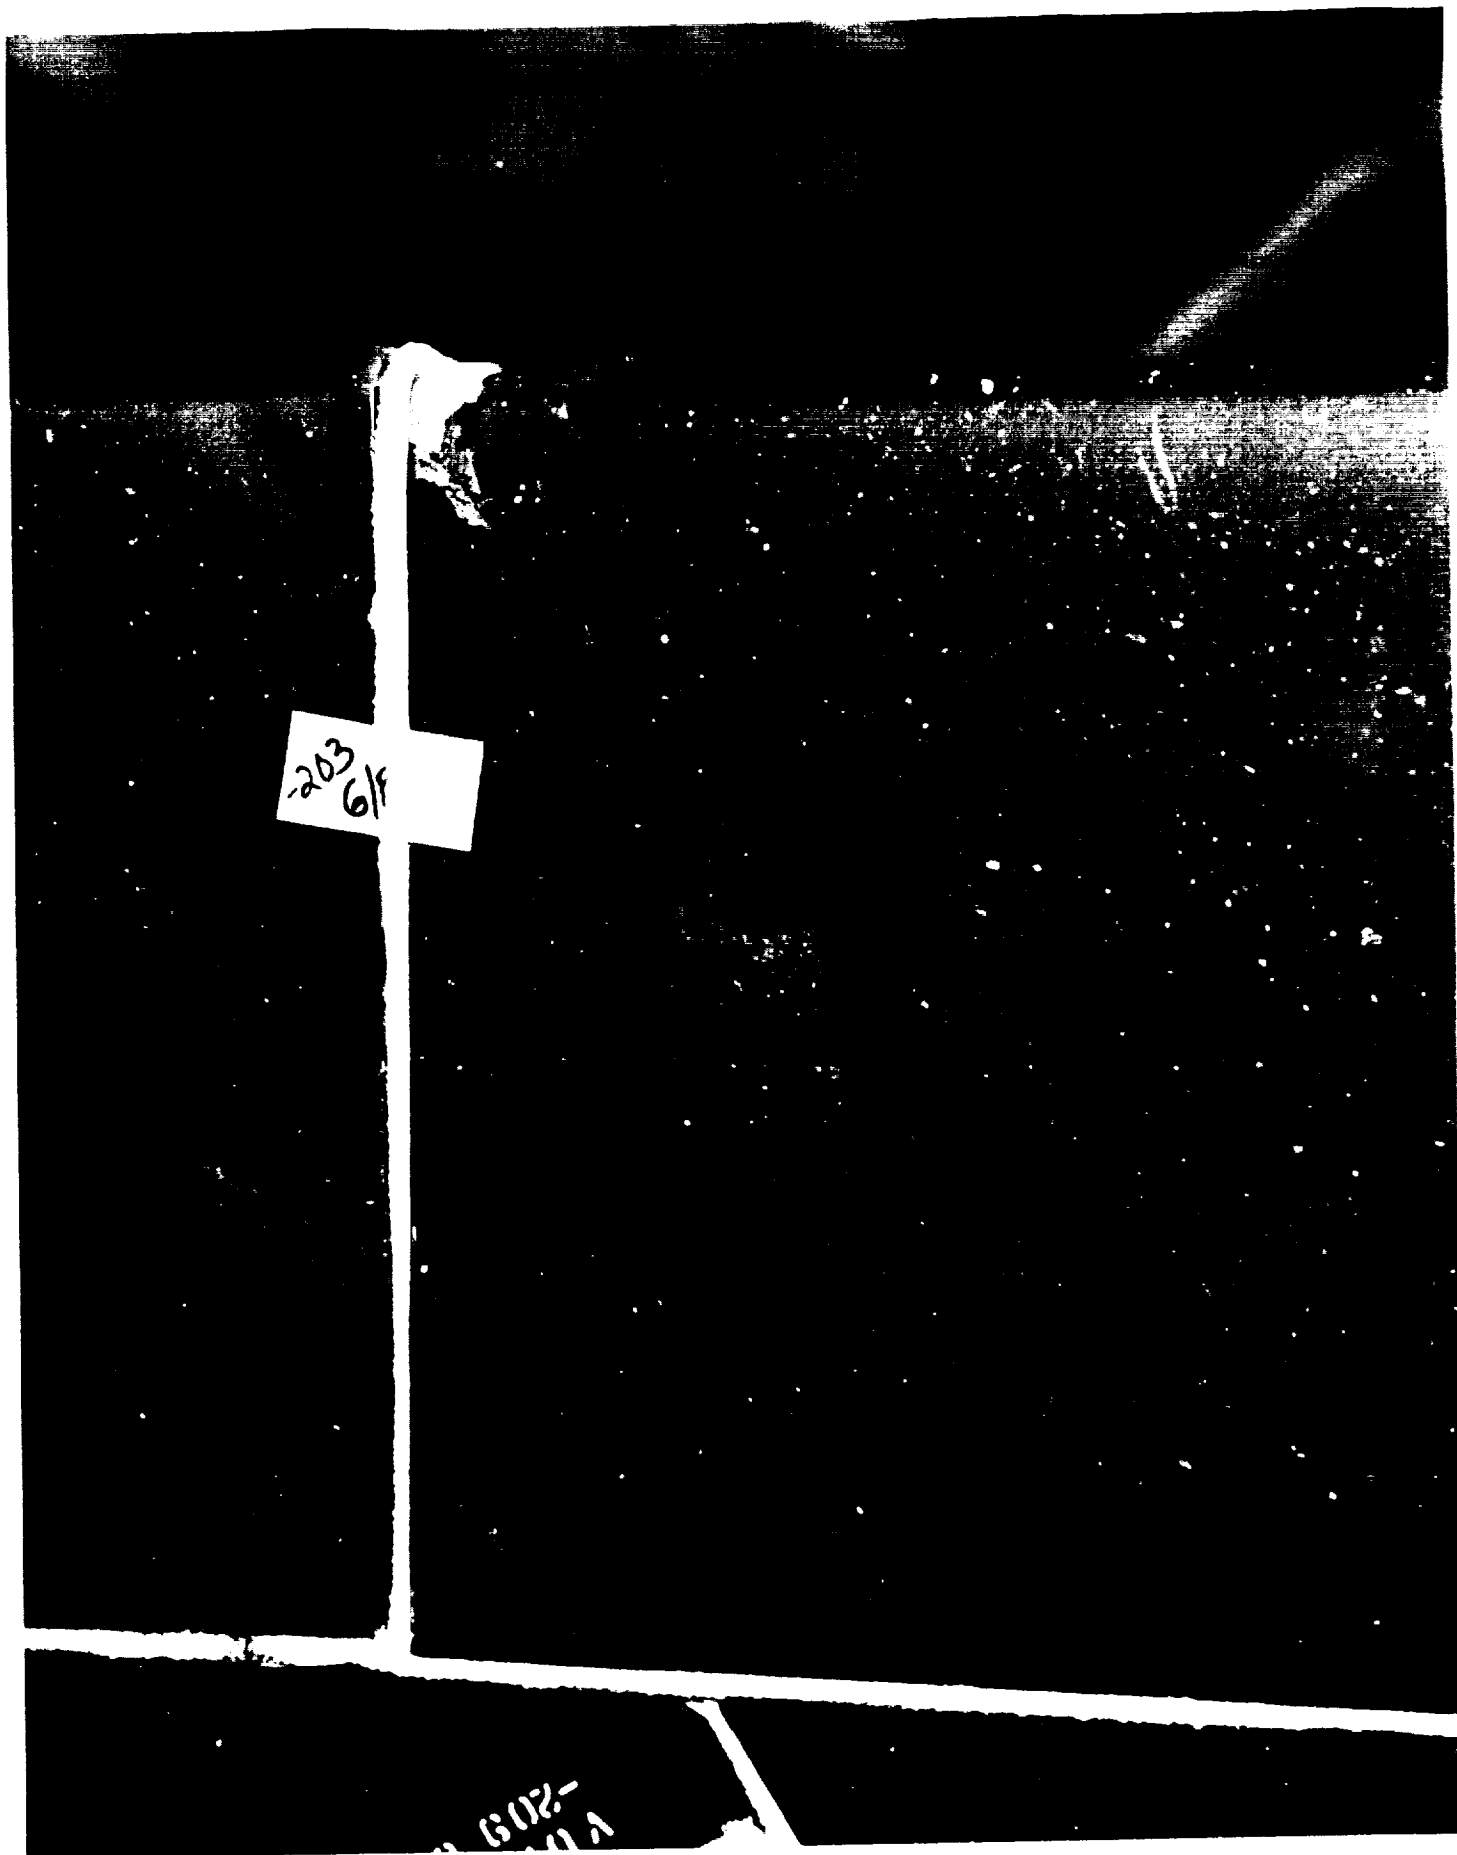
SRB RESIDUE ON BODY FLAP LH EDGE LOWER SURFACE

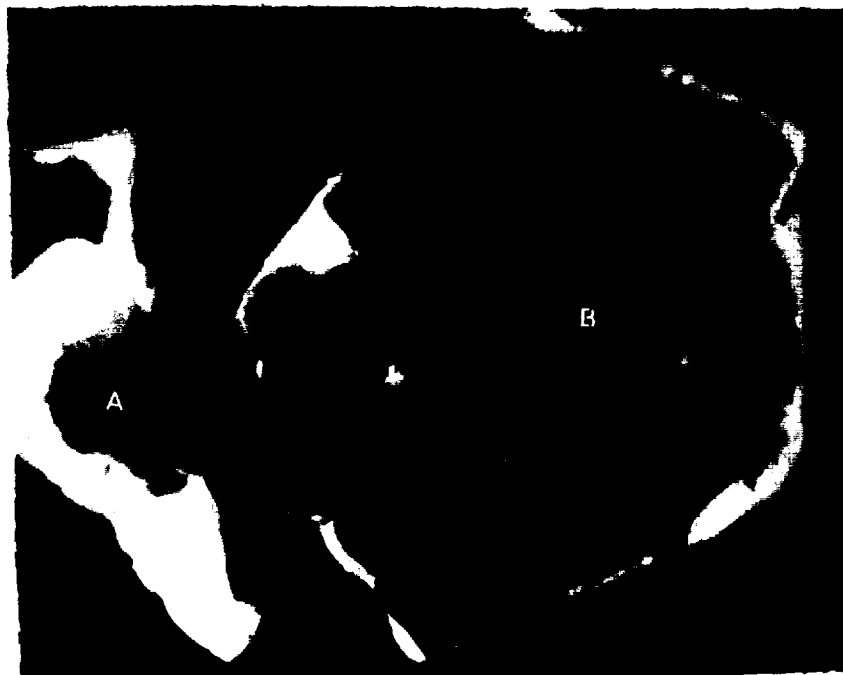
2.2.1 Figure 1 is low OM photomicrograph of debris from sample #1 to show the areas of analysis, the fused appearance of surface and depressed areas of black tiles. Figure 2 is high magnification OM photomicrograph of the area A in Figure 1 to show the fused appearance of silica tile and cracks developed on the black tile surface.

FIGURE 1. LOW MAGNIFICATION OPTICAL
PHOTOMACROGRAPH OF SAMPLE #1 TO SHOW THE AREAS OF
ANALYSIS AND THE DEPRESSED AREAS (A, B). 1X
